OFFICE OF MINE RECLAMATION

California's Abandoned Mine Lands Program Fact Sheet Abandoned Mine Inventory and Remediation

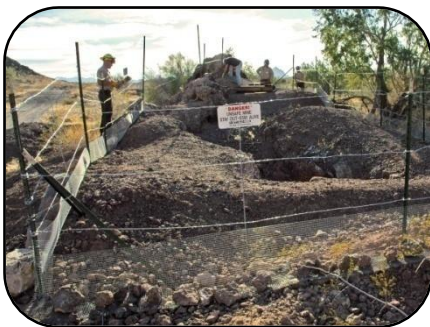
Fence, Imperial Co.

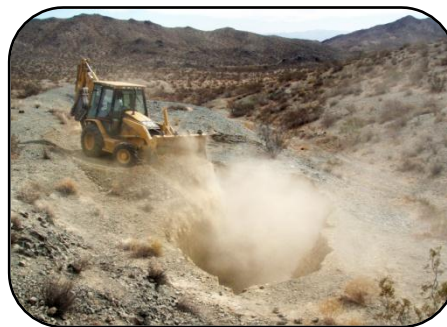
Backfill, San Bernardino Co.

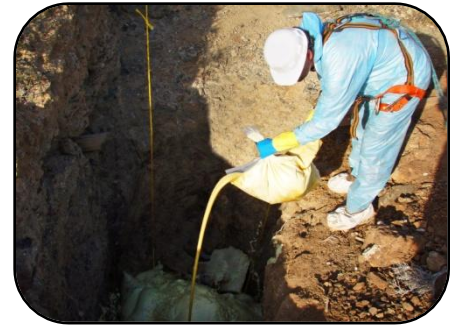
PUF closure in progress, Inyo Co.

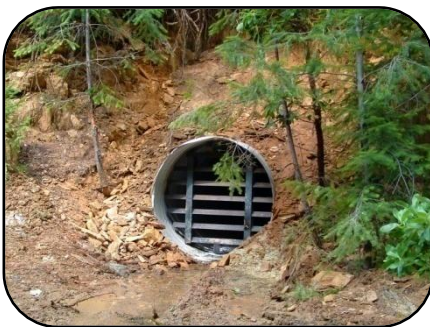
Culvert gate, El Dorado Co.

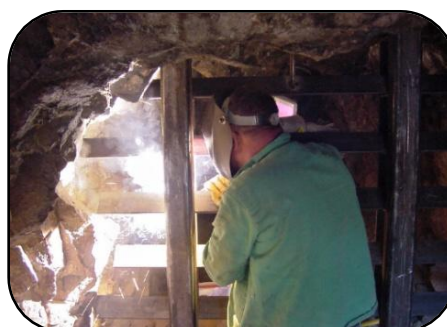
Bat gate in progress, Riverside Co.

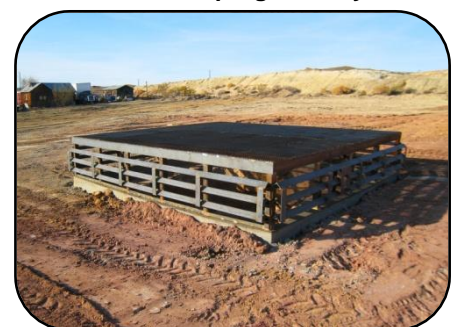
Bat cupola, Kern Co.
